Percutaneous paravalvular leak closure after CoreValve transcatheter aortic valve implantation using an arterio-arterial loop

Abstract: Significant periprosthetic aortic regurgitation after transcatheter aortic valve implantation has become a major concern of this technique given its association with impaired survival. We report the successful closure of such defect using a vascular occlusion device with the creation of an arterio-arterial loop to gain enough support to advance the delivery sheath into the left ventricle.

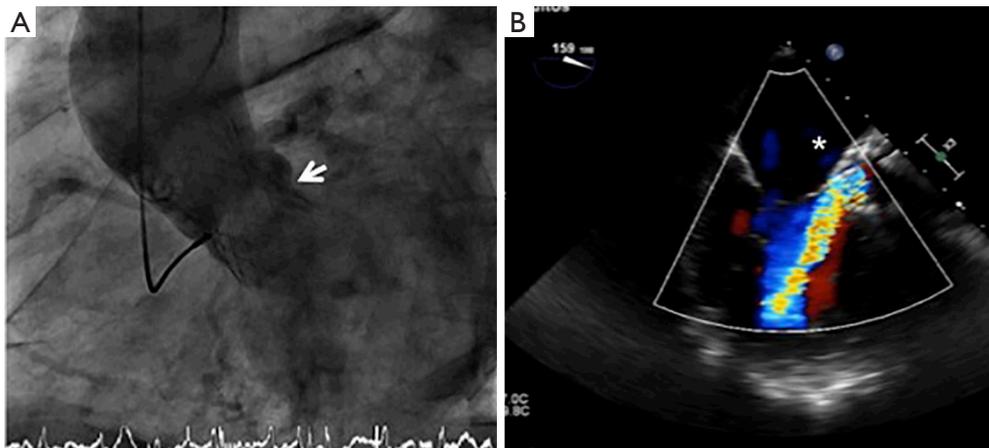
Figure 1 Severe paravalvular leak. (A) Aortogram showing severe aortic regurgitation due to paravalvular leak (arrow); (B) TEE in LVOT projection demonstrating the presence of a wide jet of aortic insufficiency close to anterior mitral leaflet (asterisk). TEE, transesophageal echo; LVOT, left ventricular outflow tract.

An 84-year-old male was admitted to our Institution due to symptoms and signs of heart failure. Diagnostic work-up revealed the presence of a severe aortic stenosis with moderately impaired left ventricular function (LVF 35%). He was scheduled for transcatheter aortic valve implantation (TAVI), since the patient was considered at a high surgical risk. The patient received a 29-mm CoreValve (Medtronic Inc., Minneapolis, USA) through transfemoral route. Due to significant paravalvular regurgitation (PVR) the valve was post-dilated with a 25-mm Nucleus balloon (NuMED, NY, USA) with the final result of moderate (2+) PVR. The course was uneventful after the procedure and the patient was discharged home. However, at 3-month follow-up the patient complained of symptoms of heart failure. A transthoracic echocardiogram revealed the presence of severe PVR and a severely impaired LVF (20%). Transesophageal echo (TEE) and invasive angiogram showed a severe crescent-shape PVR of 10 mm width located in the posterior aspect of the TAVI frame with patent coronary arteries (Figures 1-3). After discussion with the heart team the patient was considered a candidate for transcatheter paravalvular leak (PVL) closure.

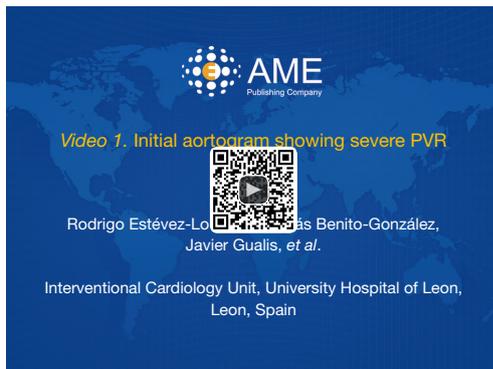
Figure 2 Initial aortogram showing severe PVR (1). PVR, paravalvular regurgitation.

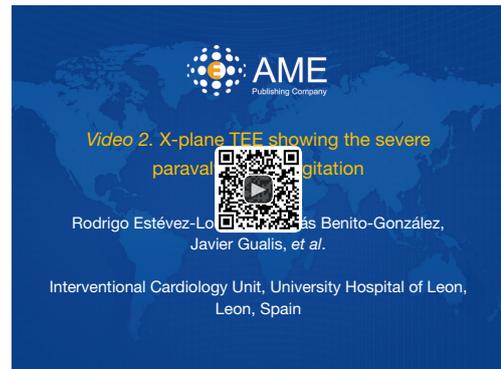
Figure 3 X-plane TEE showing the severe paravalvular regurgitation (2). TEE, transesophageal echo.

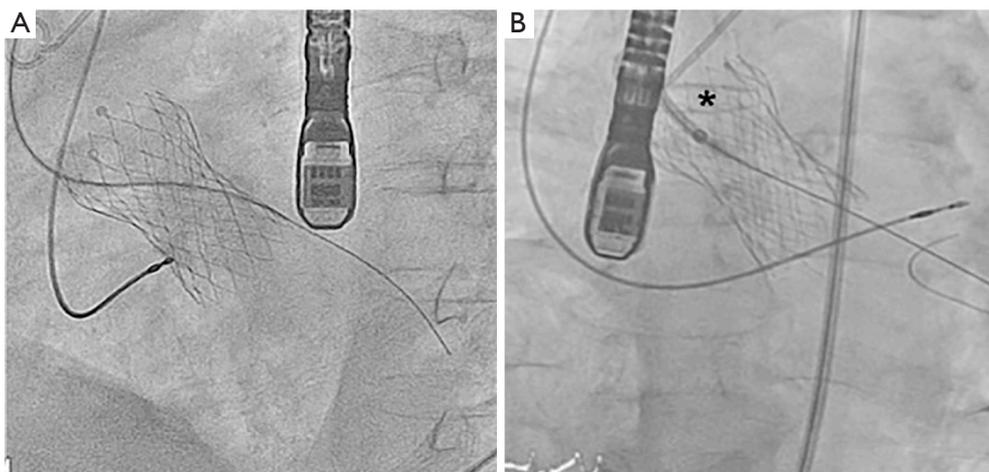
Figure 4 Interventional procedure. (A) Through an AL1 catheter a straight tip Terumo wire was advanced into the LV; (B) severe resistance was encountered and the TorqVue sheath (asterisk) could not pass through. Severe calcification is noted in the annulus.

aortography) and left femoral arteries (for procedure). Through femoral route a 6-Fr AL1 diagnostic catheter (Cordis, USA) and a 0.0035' straight Terumo wire were used to probe the defect (Figure 4A). The leak could be crossed and 4 Fr Terumo Glidecath diagnostic catheter (Terumo Medical Corporation, USA) was placed in the LV cavity. Terumo wire was exchanged by a Confida wire (Medtronic Inc., Minneapolis, USA) in order to gain support to advance a 7-Fr TorqVue sheath for AVP-III device insertion (St Jude Medical, USA; selected based upon the measurements of TEE). However, after several attempts the sheath could not be advanced to the LV due to the severe annulus calcification (Figure 4B). Then, the defect was crossed with the AL1, but this time through the radial access. Once the wire was advanced to the LV, it was manipulated into the LV to direct the tip to the left ventricular outflow tract (LVOT) and cross the TAVI leaflets to reach the ascending aorta. Since we had our 7 Fr TorqVue sheath located in that position we were able to directly insert the Terumo wire inside, thus creating an arterio-arterial loop (Figures 5,6). The TorqVue sheath was kept in place to increase the support and a 7.5-Fr JR4 Sheathless catheter (Asahi, Japan) inserted through radial artery was advanced into de

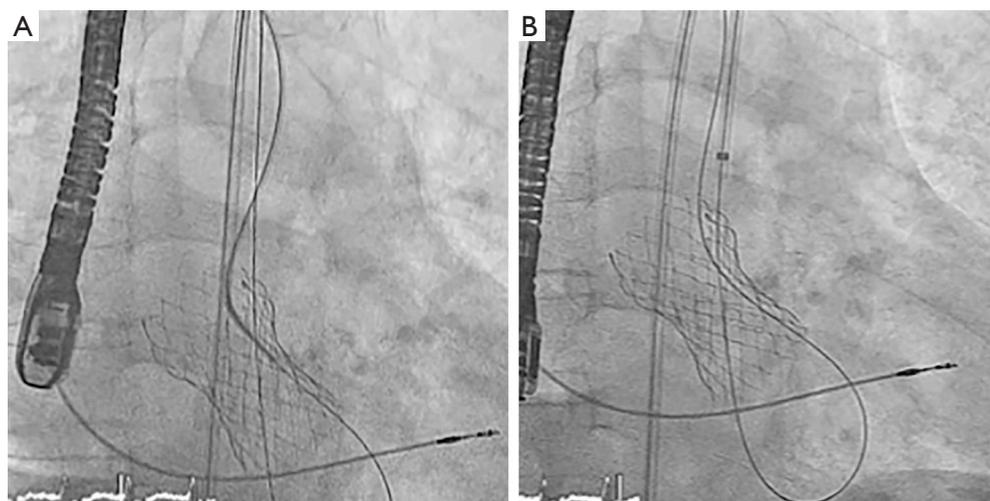
Figure 5 Interventional procedure with creation of the arterio-arterial loop. (A,B) The Terumo wire crosses the defect and is externalized through the middle of the valve and then inserted into de femoral sheath.

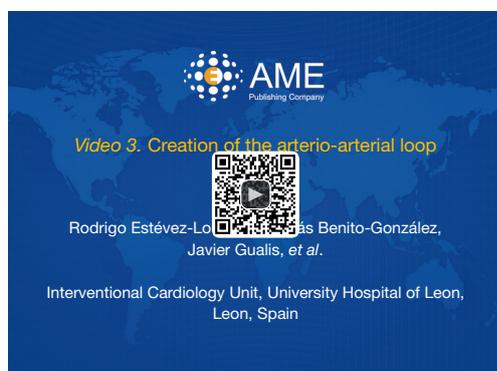
Figure 6 Creation of the arterio-arterial loop (3). Available online: <http://www.asvide.com/articles/1379>

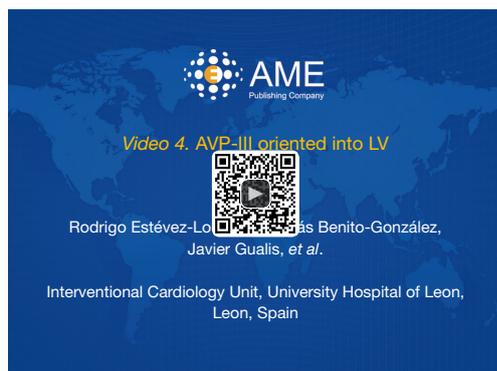
Figure 7 AVP-III oriented into LV (4). AVP, amplatzer vascular plug; LV, left ventricle. Available online: <http://www.asvide.com/articles/1380>

LV. Then a 10 mm × 4 mm AVP-III was positioned into the LV. We firstly unsheathed completely the device in order to orientate it with its long axis parallel to the major defect diameter (Figure 7). Once the occluder was properly oriented it was partially recaptured to be positioned into de defect. Eventually the device was implanted with significant reduction of the PVR to mild degree (Figures 8,9). A buddy-wire was left into de LV in case a second occluder was required. However, echo, angiogram and hemodynamic measurements confirmed the excellent result of the case, so no more devices were needed (Figures 10-12).

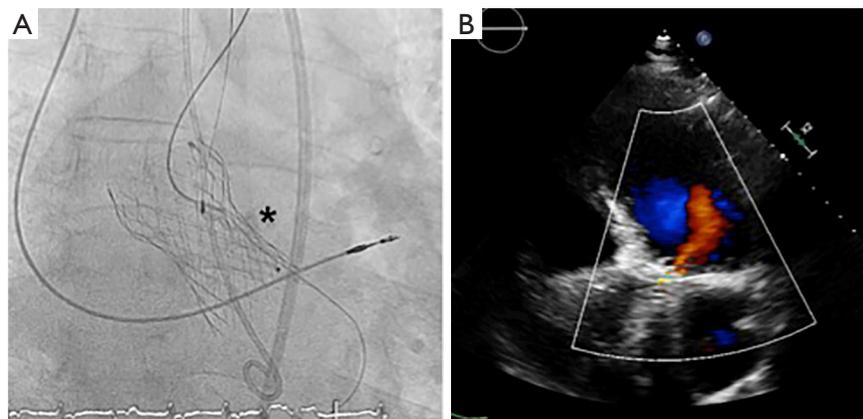
Figure 8 Deployment of closure device and result. (A) AVP-III deployed through the defect (asterisk); (B) TTE showing mild aortic regurgitation. AVP, amplatzer vascular plug; TEE, transesophageal echo.

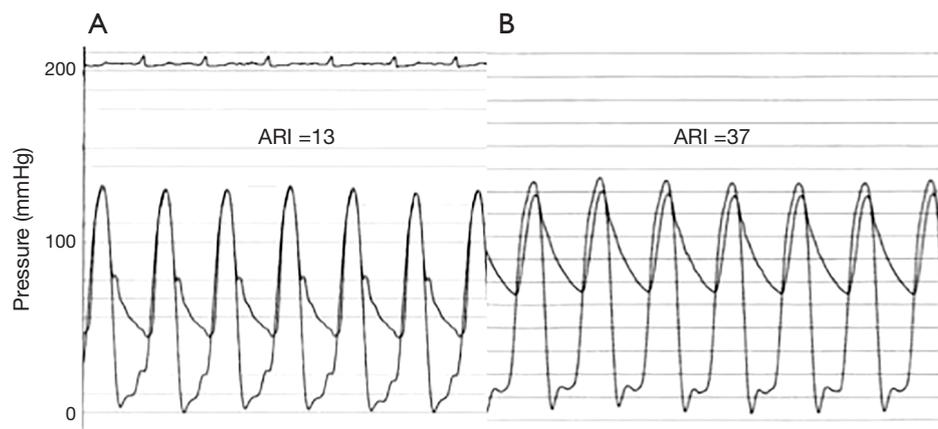
Figure 10 Hemodynamic measurements. (A,B) Hemodynamic measurements pre and post deployment of the device. There is a significant improvement after occlusion of the PVL with a normalization of the aortic regurgitation index (ARI). PVL, paravalvular leak.

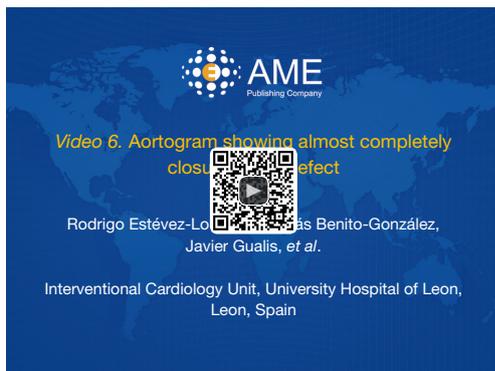
Figure 11 Aortogram showing almost completely closure of the defect (6).

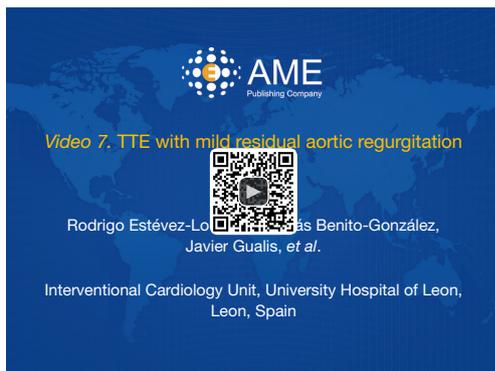
Figure 12 TTE with mild residual aortic regurgitation (7). TEE, transesophageal echo.
